# Maintenance – 4300 Mile Decoke Sept2004

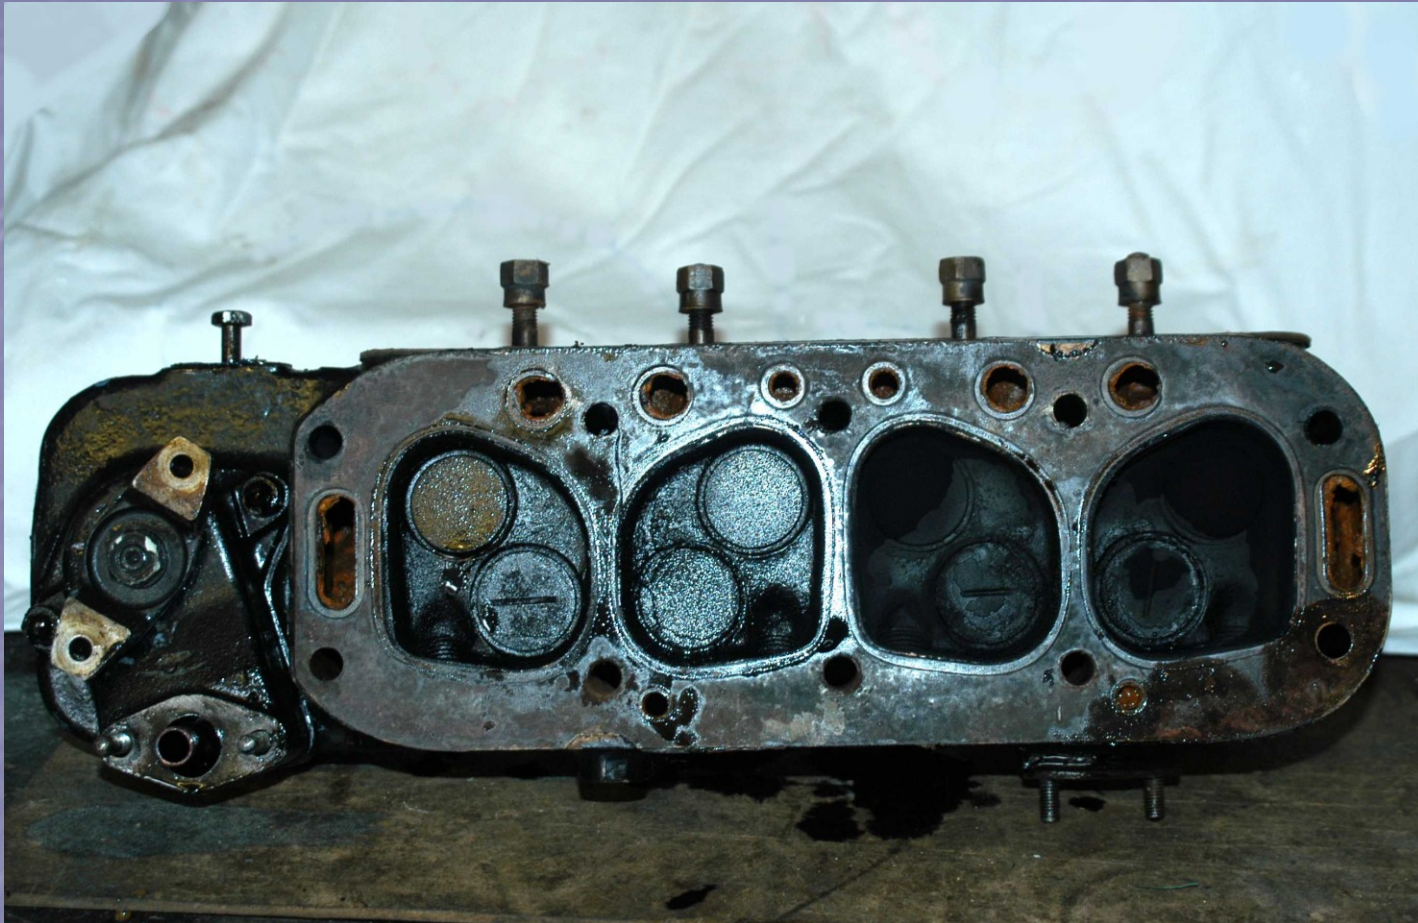
# Condition of Cylinder Head as Found

The oily appearance of the combustion areas of Cyl. #1&2 was probably due to the diagnostic 'wet' combustion test. Since only Cyl #1 had added oil, it appears this has leaked to Cyl #2 indicating a faulty head gasket

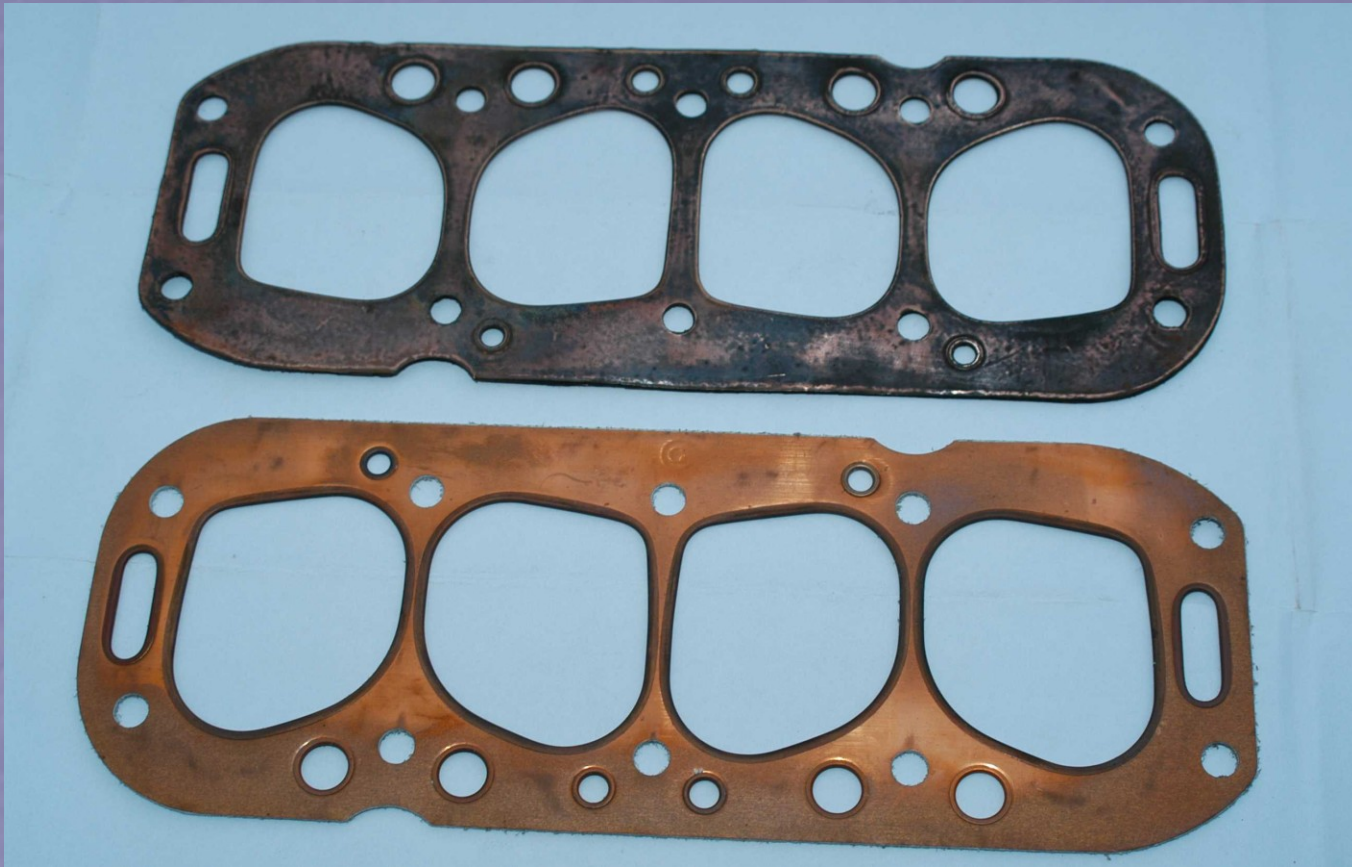
# Head Gasket Old & New

Apart from discolouration and some minor indentations the used Gasket showed no evidence of any cross cylinder leaks

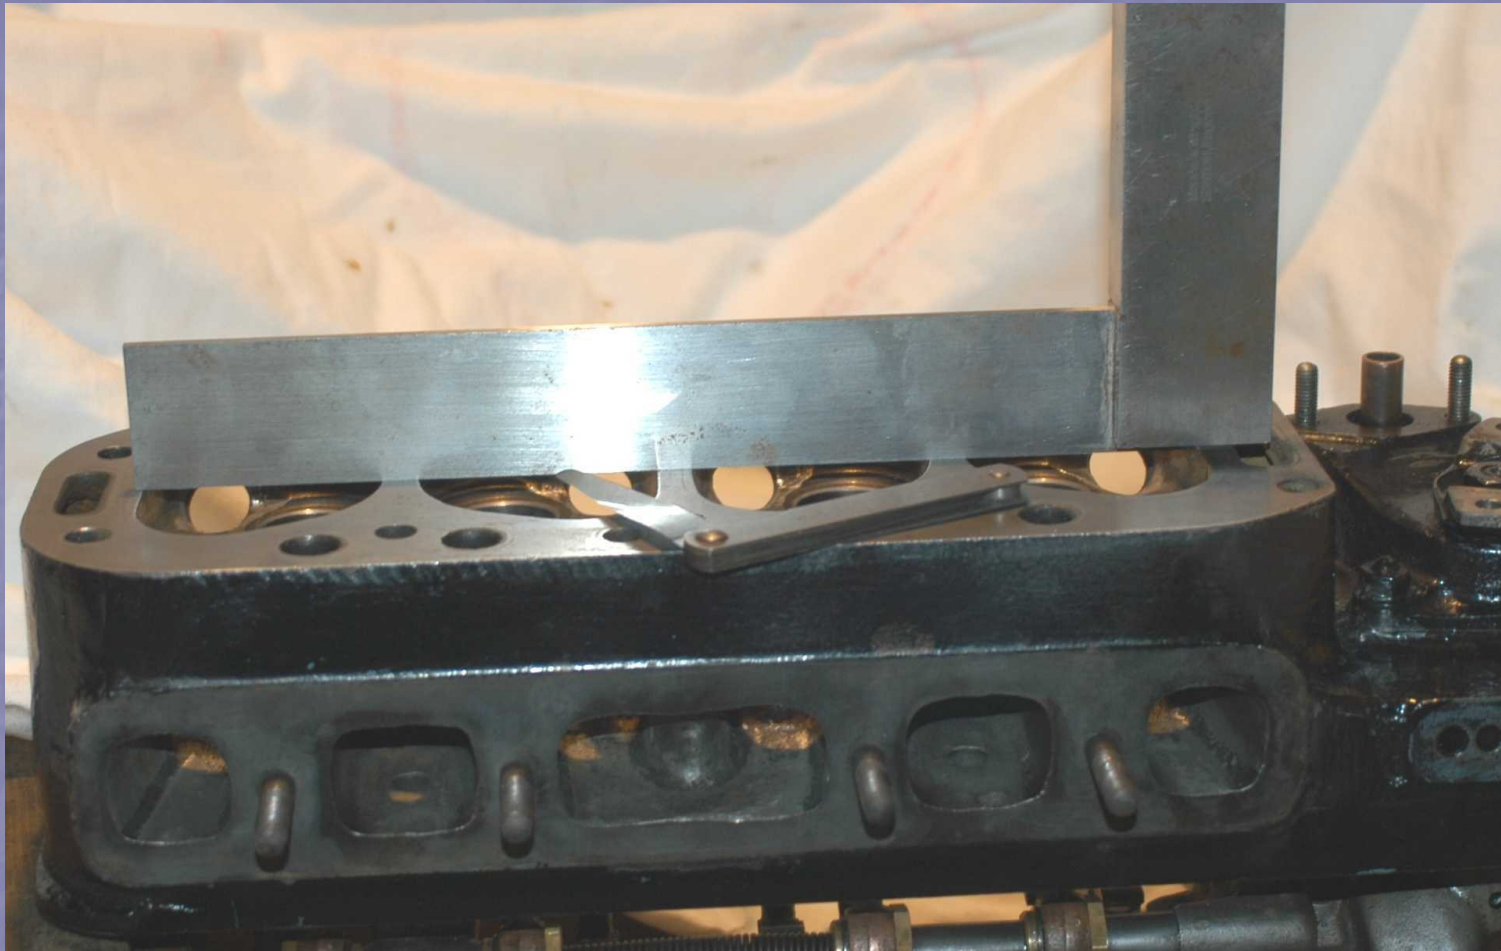
# Cylinder Head Straightness Check

**No distortion of the cylinder head could be detected ruling out any over heating causing the compression loss**

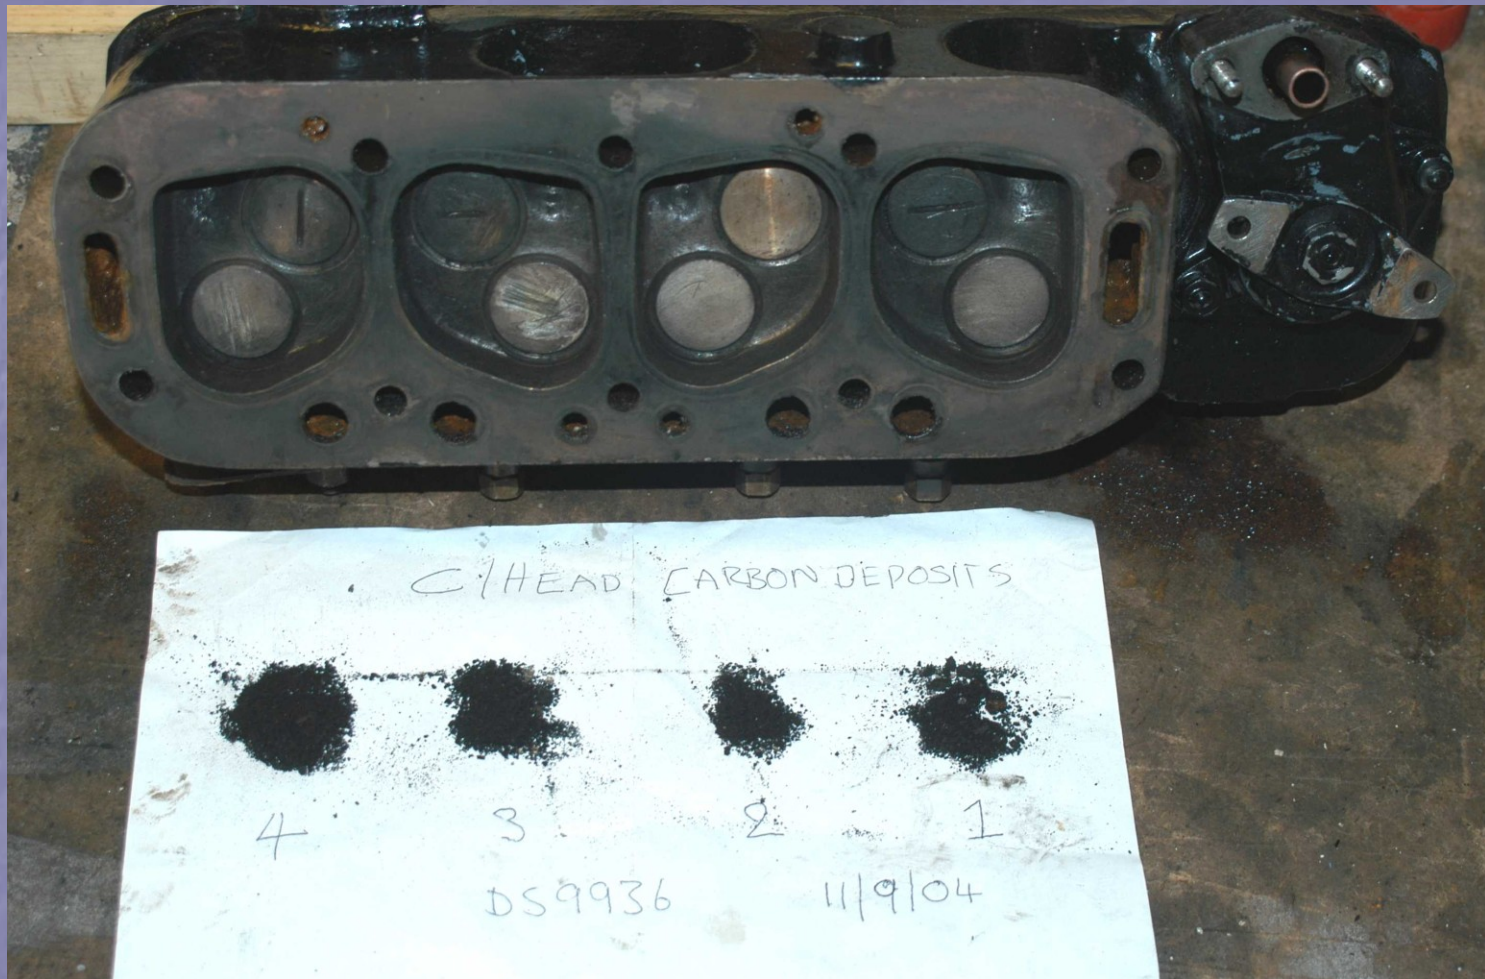
# Carbon Deposits Removed from Cylinder Head

Considering that only 4000 miles had been covered the amount of deposit was less than expected. However, the engine had a history of running rich.

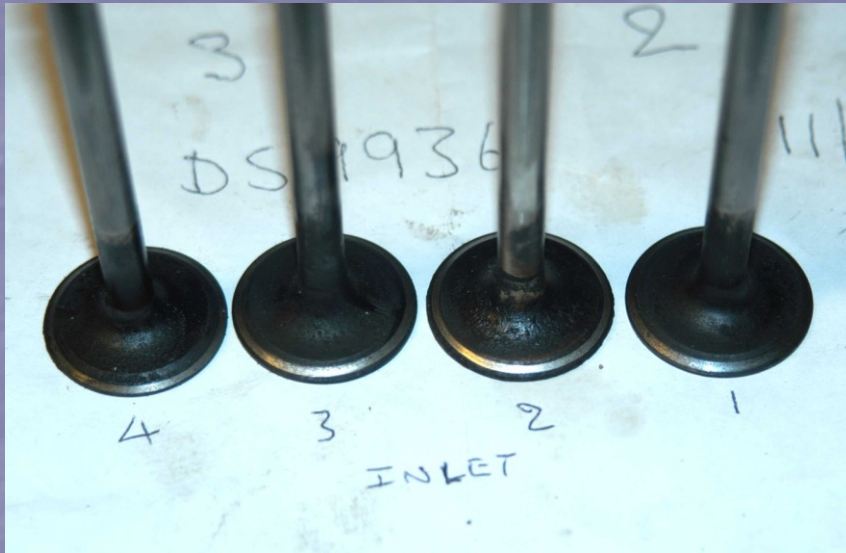
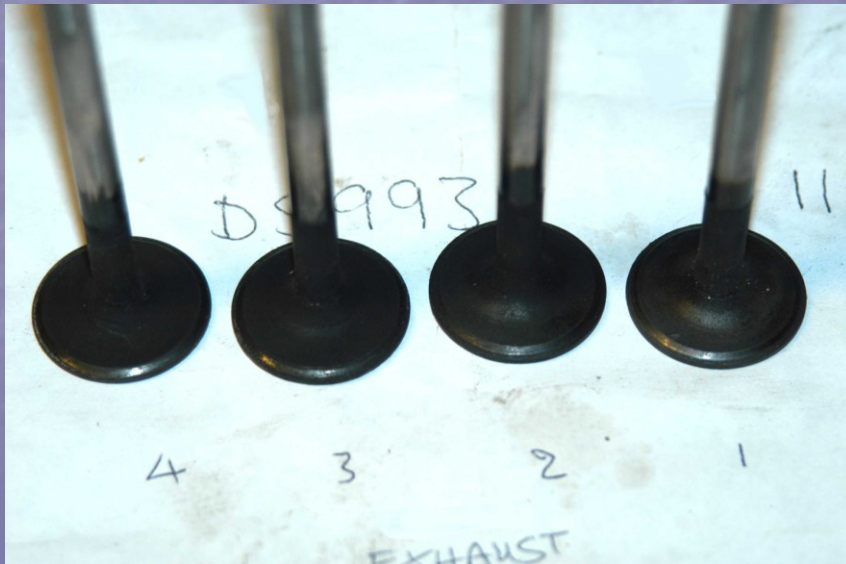
# Inlet & Exhaust Valves as Removed

- The Valves as removed before cleaning.
- No indications of poor sealing were seen

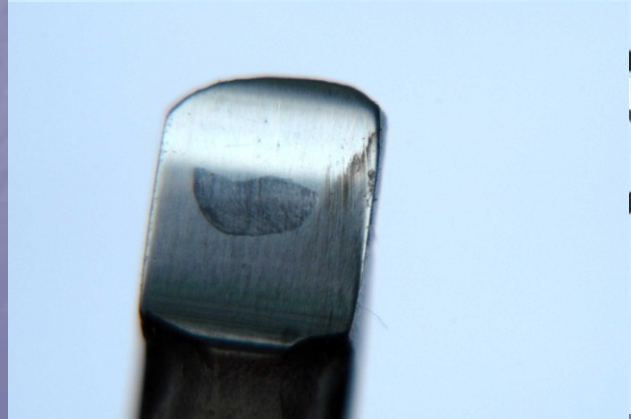
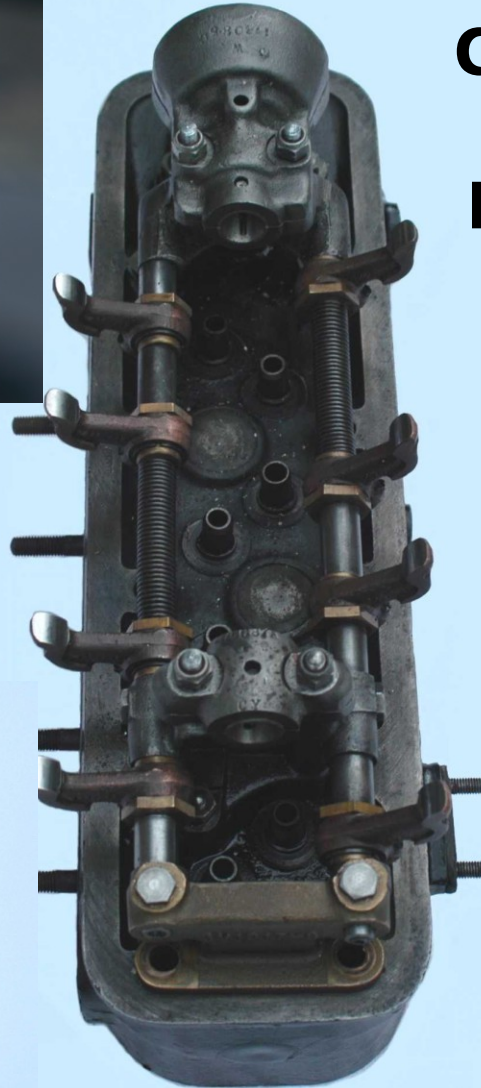
**Valve  
Follower  
Wear**

**The valve  
follower wear  
is considered  
acceptable**

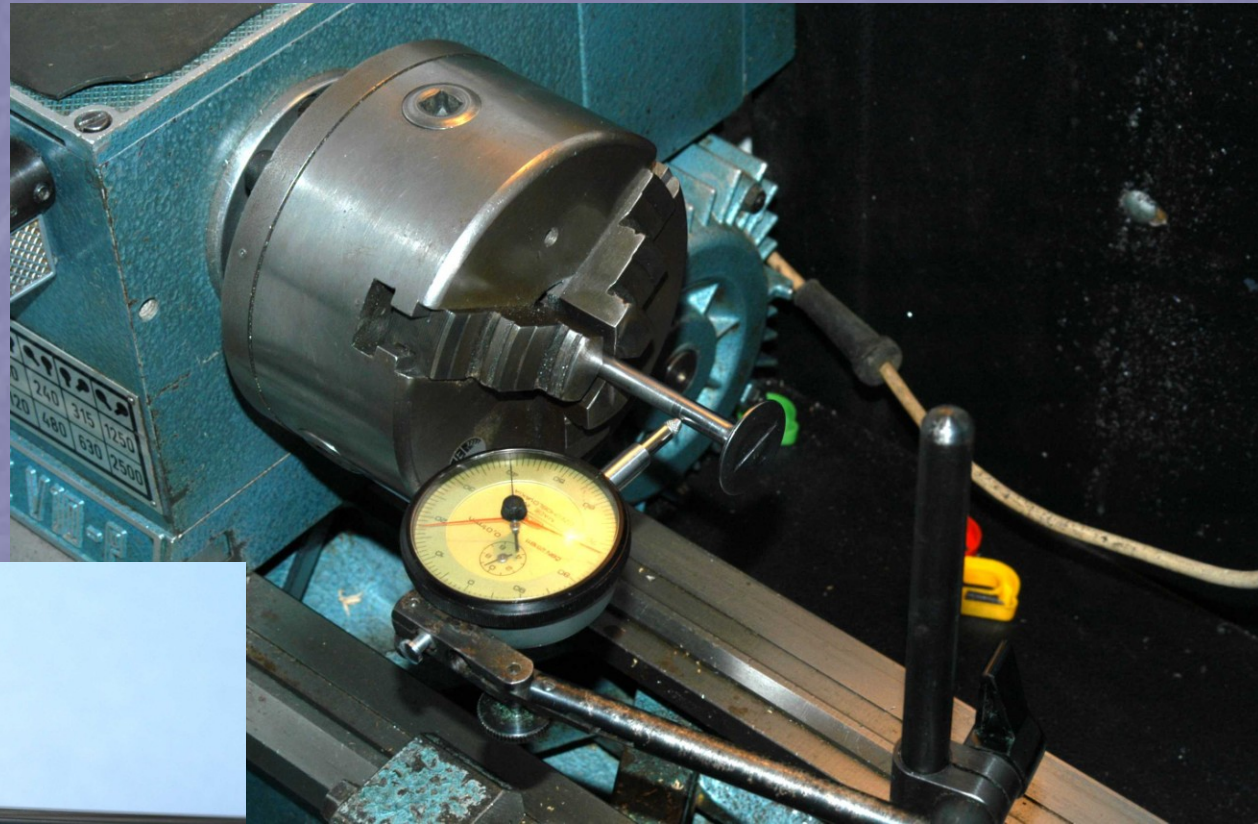
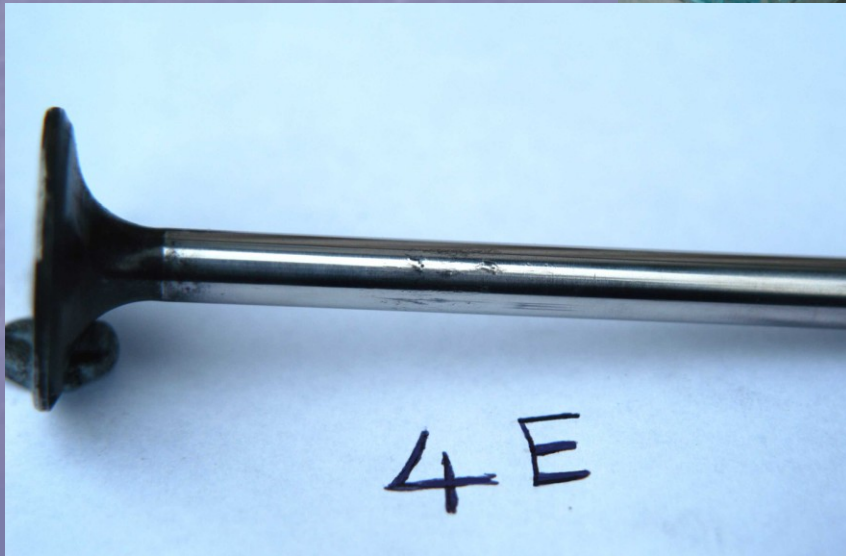
# Valve Inspection

Exhaust Valve on #4 Cylinder was found to have a metallic deposit on its shaft. This was carefully removed.

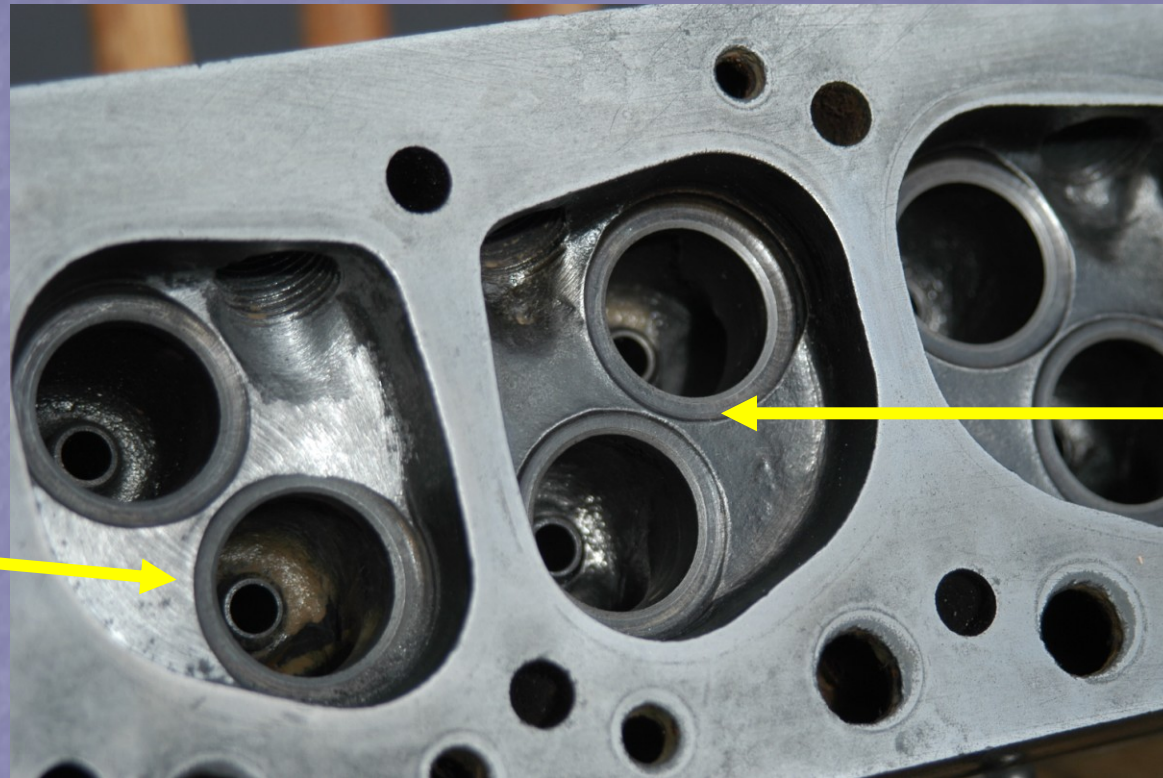
# Valve Seats

When valve seats are cut and ground a ridge is left that allows carbon to build up on the high ridges causing potential pre-ignition etc. It is advisable to remove this.

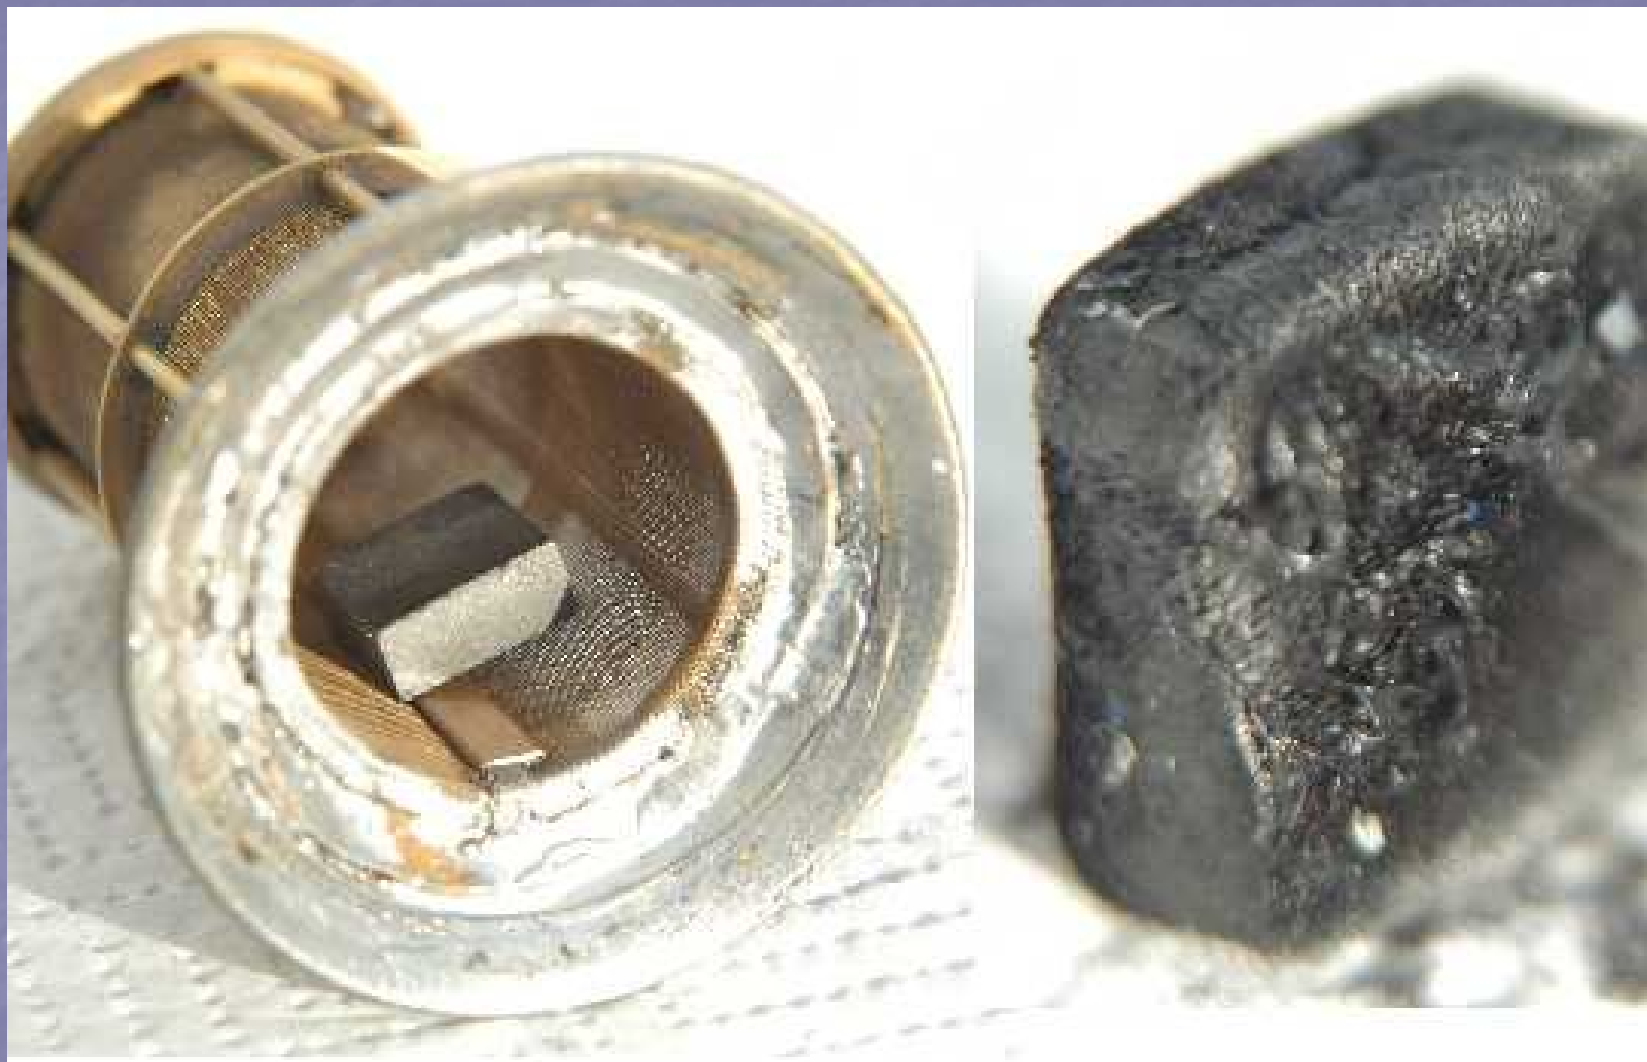
## Lubrication Change 19/11/04 After 1032 Miles - Engine

The debris right is a combination of Fe particles & gasket sealant 'Hylomar'

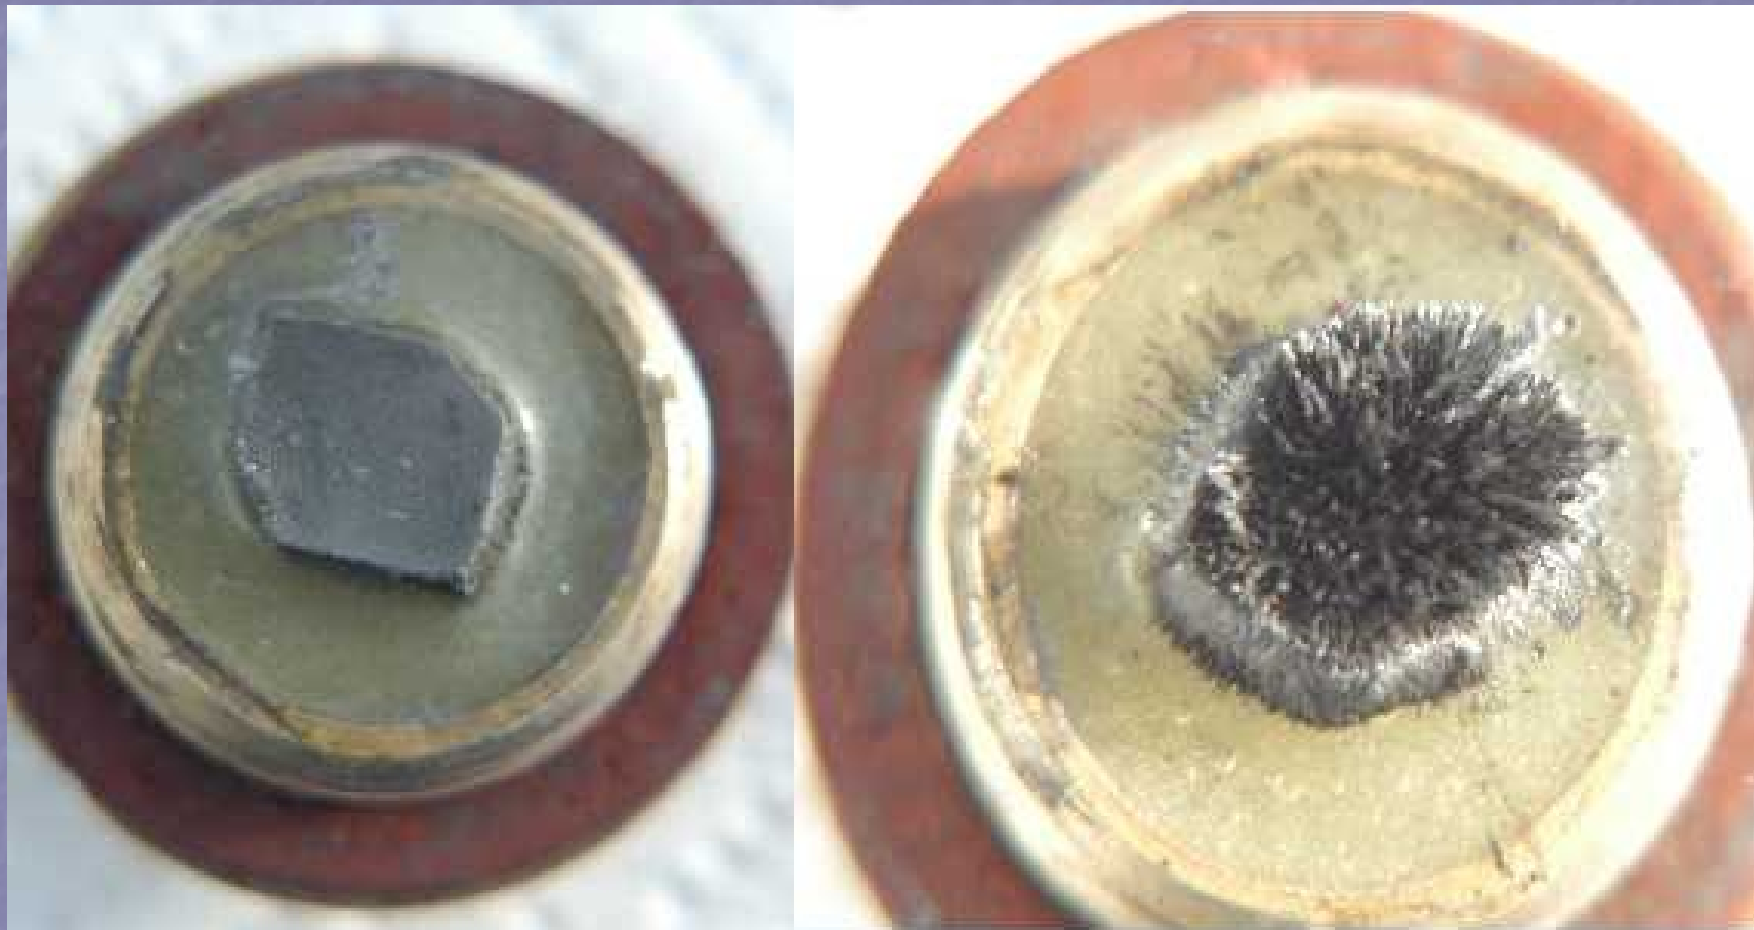
## Lubrication Change 19/11/04 After 1032 Miles – Gear Box

The amount of Fe debris on the right is indicative of excessive wear in the 'crash gear box'

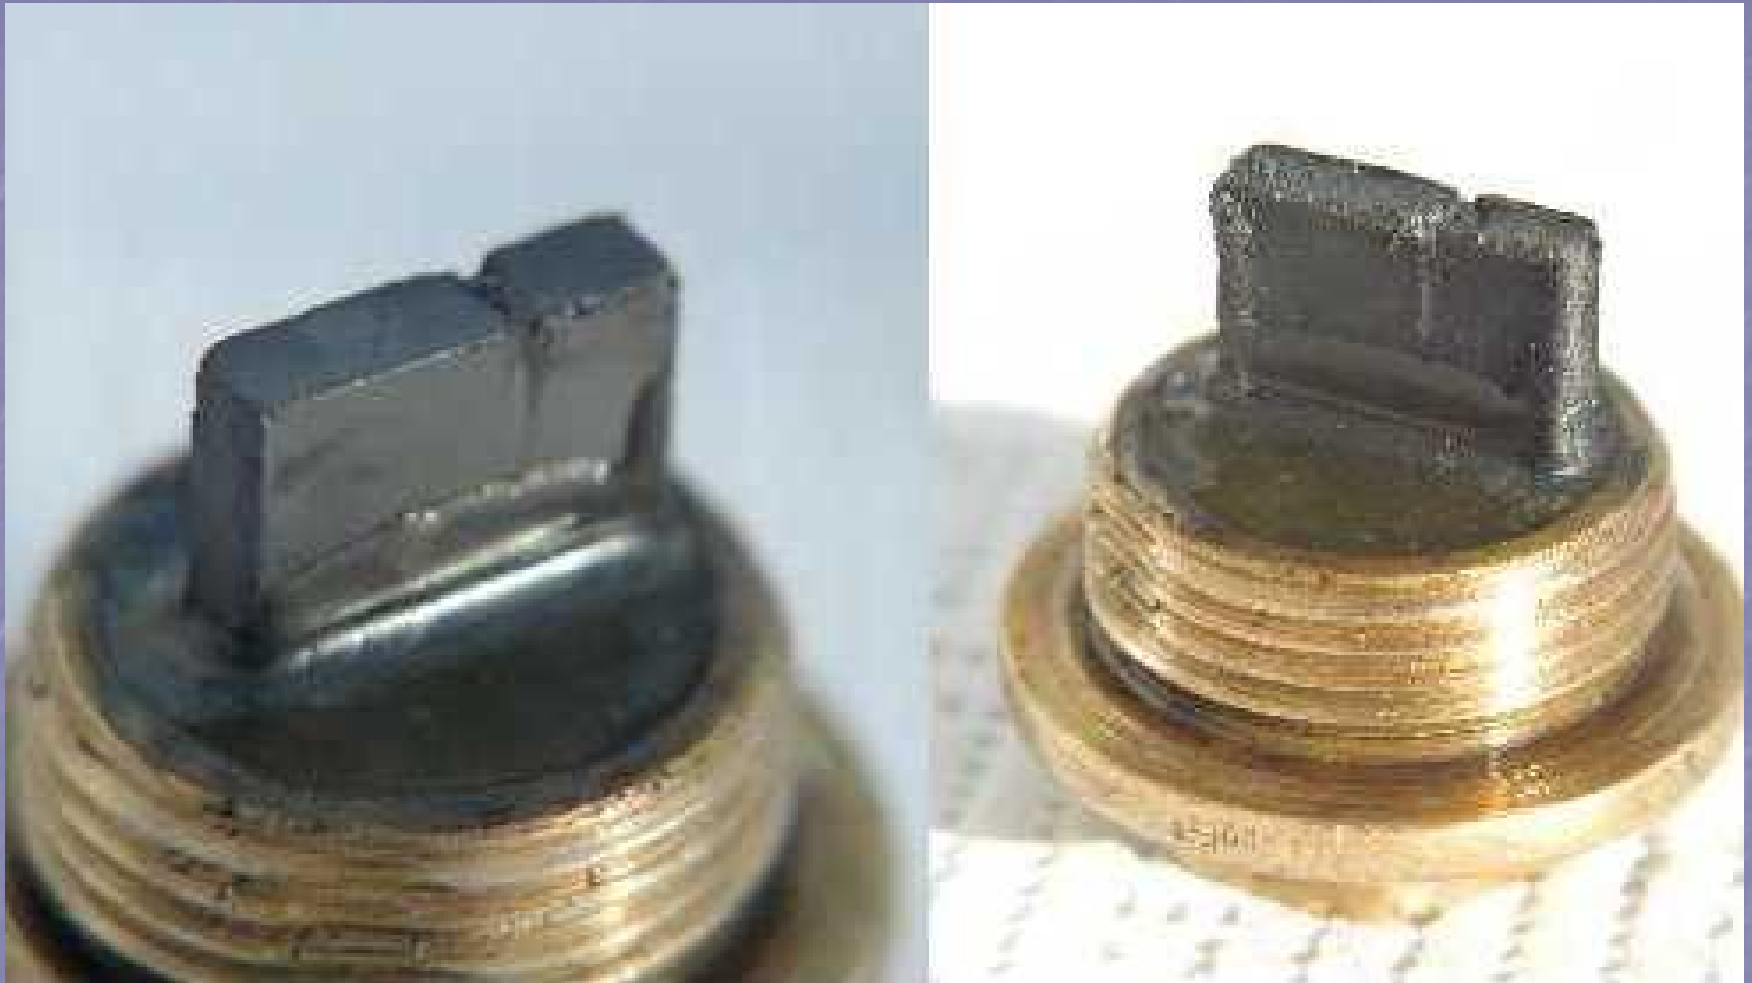
## Lubrication Change 19/11/04 After 1032 Miles - Differential

The Fe debris particles is minimal indicative of a healthy Differential

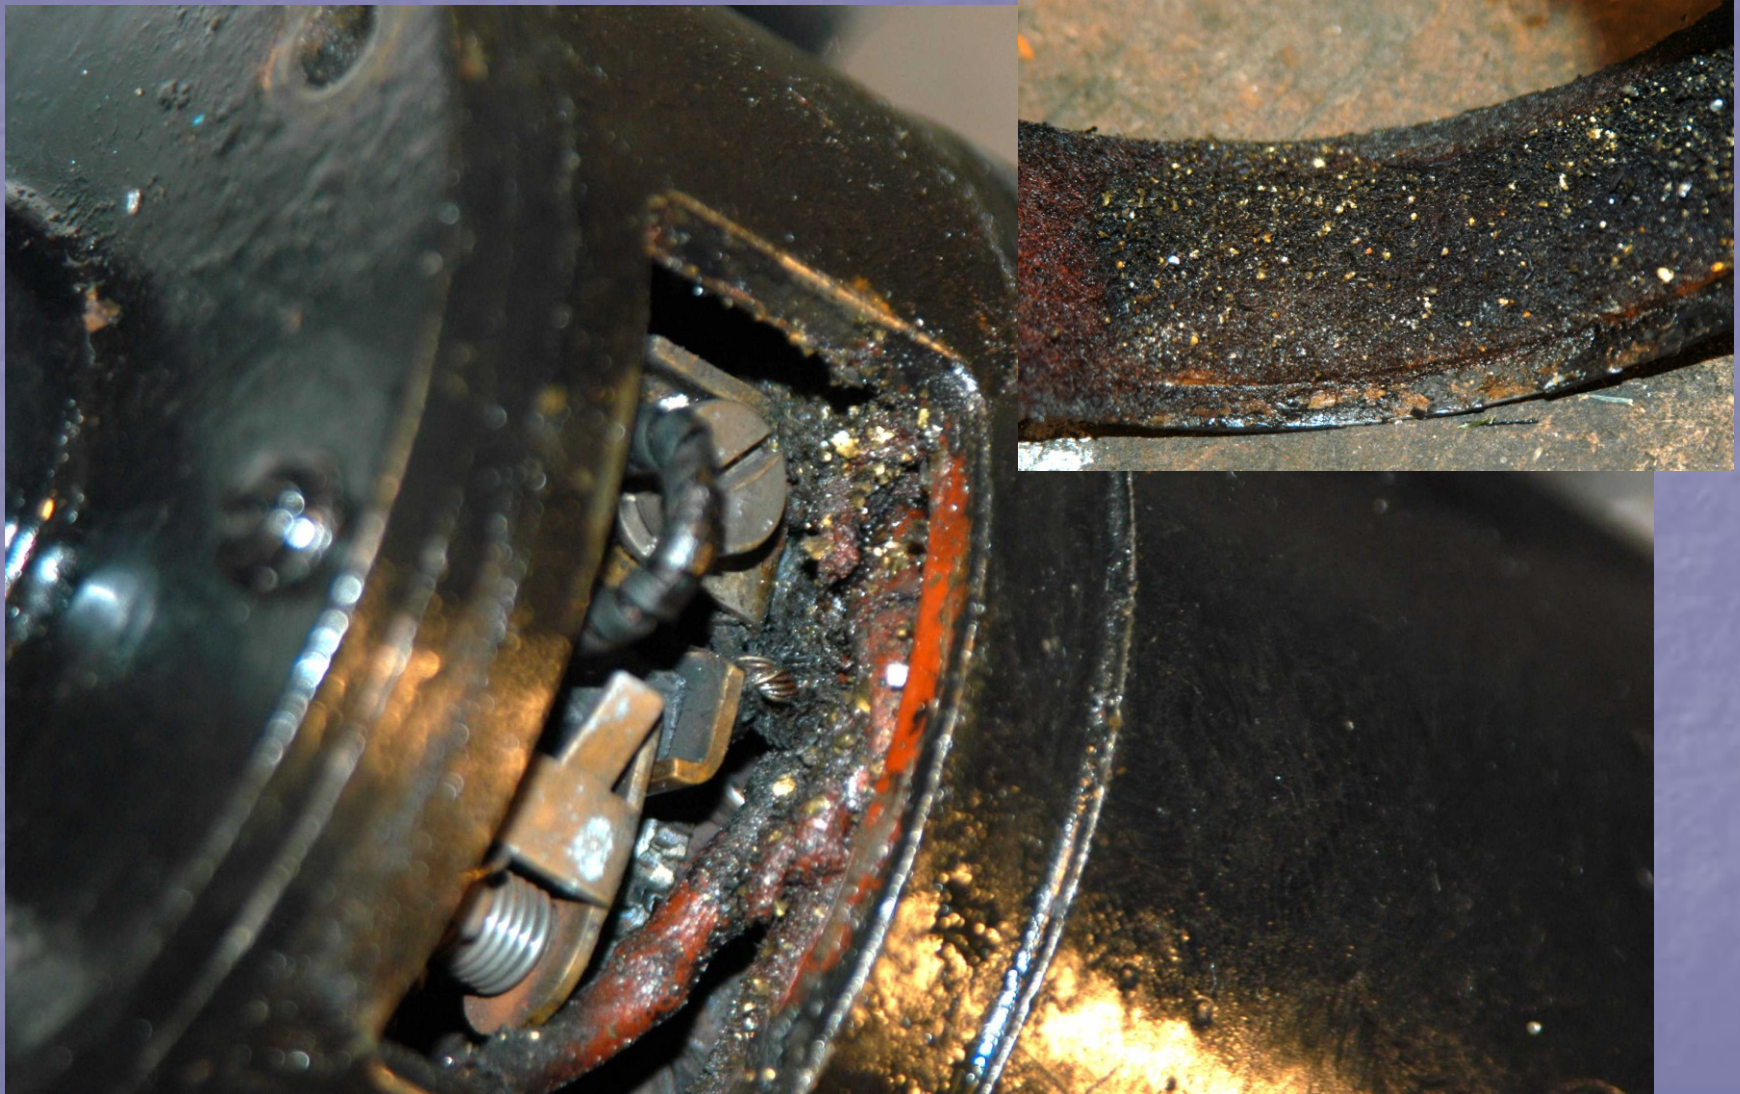
# Metallic Debris in the Brushes

- When the Cylinder Head was removed it was found that the dynamo top bearing was suspect
- On inspection it was found that the top bearing had virtually disintegrated.
- The bronze cage had totally broken up with metallic debris in the stator & armature.
- In the past the dynamo only delivered just +ve Amps
- When the lights are on the ammeter shows full negative
- It was known that some solder for connections to the commutator had 'spun off' probably due to excess heat
- This probably cause 'high resistance' joints & over heating
- The unit was in desperate condition and its discovery had probably saved the engine from catastrophic damage

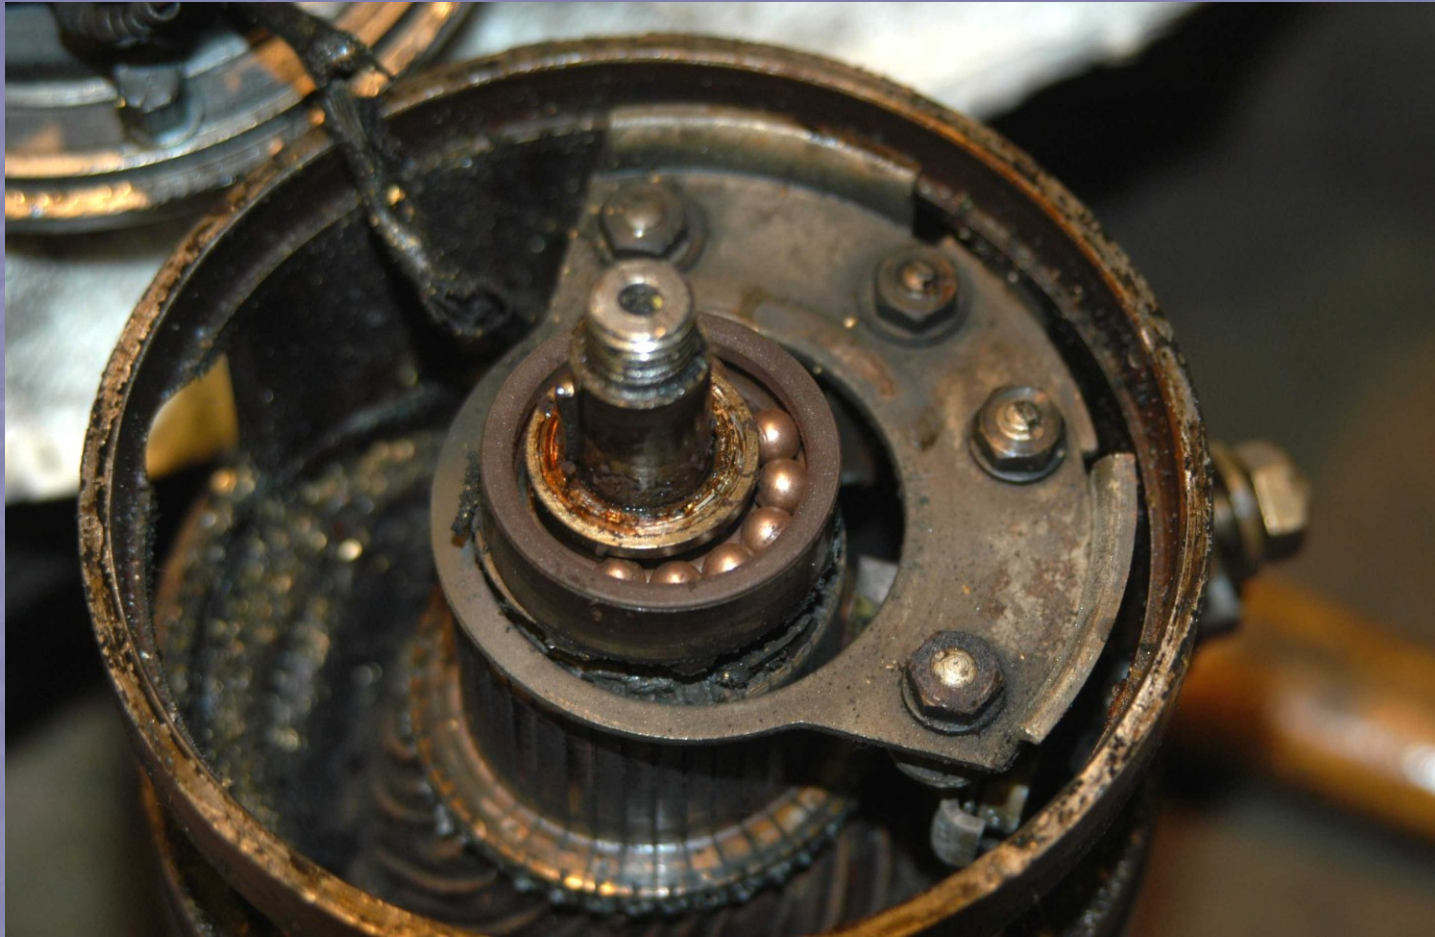
# Remains of Top Bearing Revealed

The cause of the collapsed bearing was lack of lubrication. Since the OHC drive was modified with a sealed bearing, any past oil leaks would have lubricated the dynamo top bearing! Future replacement bearings will be the sealed type.

- The Top and Bottom bearings were replaced with 'sealed types to avoid the need to lubricate which was the cause of the original bearing collapse
- Replacement Top was Model LJ 1/2" 2RS
- Replacement Bottom was Model LJ 3/4" ZZ
- Note: the Top Bearing is locked into the housing by a grub screw concealed under the insulating ring
- The Bottom Bearing had moved in its housing so "Loctite Bearing Fit" was applied to alleviate this

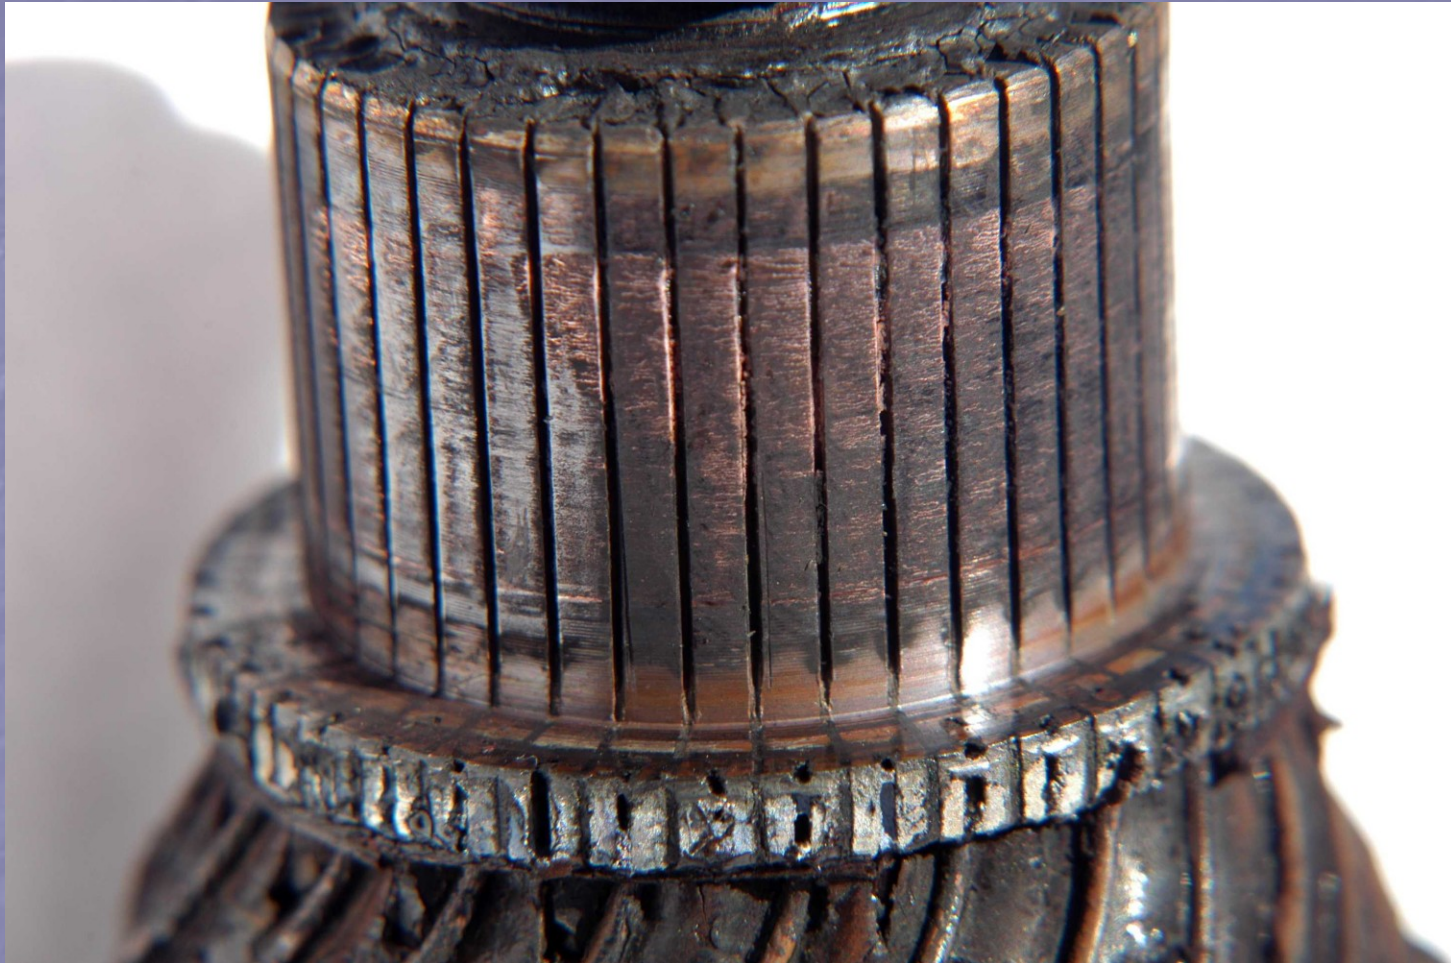
# Dynamo Condition as Found

**Commutator – Brush Arcing Burns & Poor Soldered Connections & Over Heating (Overload?)**
