Keeping 'em flying

Putting the brakes on the Lancaster

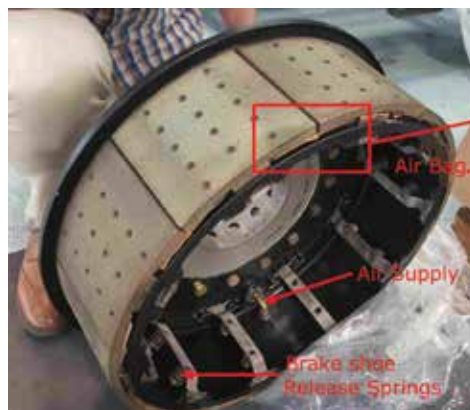
☒ Lancaster brake unit. There are 20 brake shoes per wheel, which are forced against the wheel hubs by a rubber brake bag inflated by pneumatic pressure.

The Lancaster has four brake units in total, with each of the two mainwheels having one brake unit on the inner and one on the outer hub. The four brake units each

have 10 brake shoes, so 40 brake shoes are needed for a complete set. Each brake shoe is made up of a metal backing plate and a friction-material brake pad, the two items being bonded and riveted together to form the brake shoe assembly.

When the Lancaster's brakes are applied, rubber brake bags fitted around the brake hubs inflate under pneumatic pressure to

force the brake shoes against the wheel hubs, slowing the rotation of the wheels. On releasing the brakes, the shoes are retracted under spring pressure. (The Lancaster brake bags were the subject of an urgent project some 15 years ago, when the supply of original items ran out, threatening to ground the Lancaster, and new brake bags had to be manufactured.)

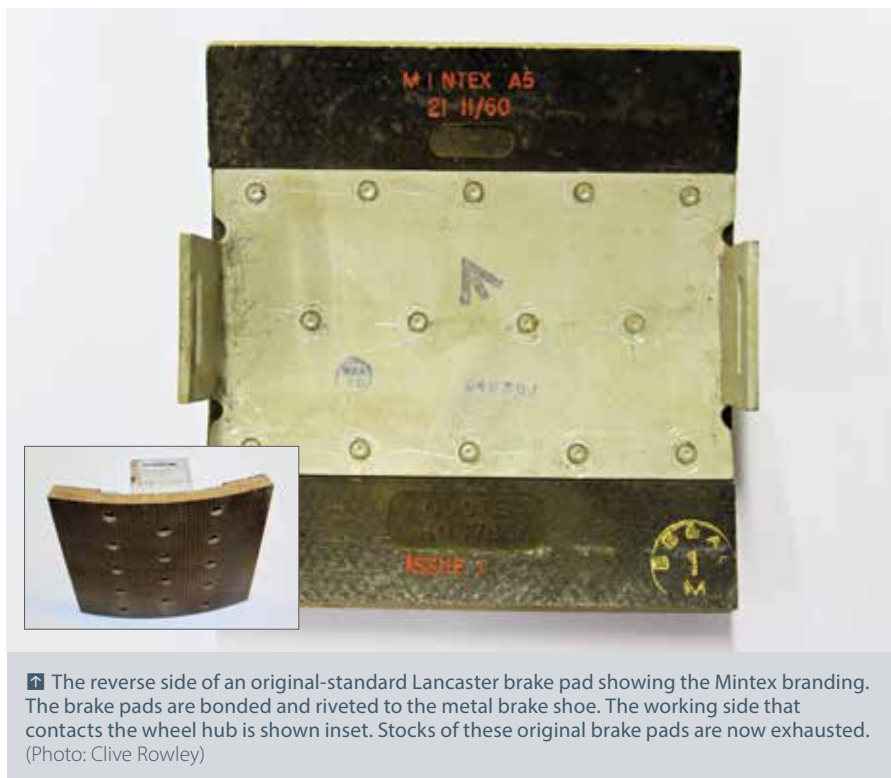
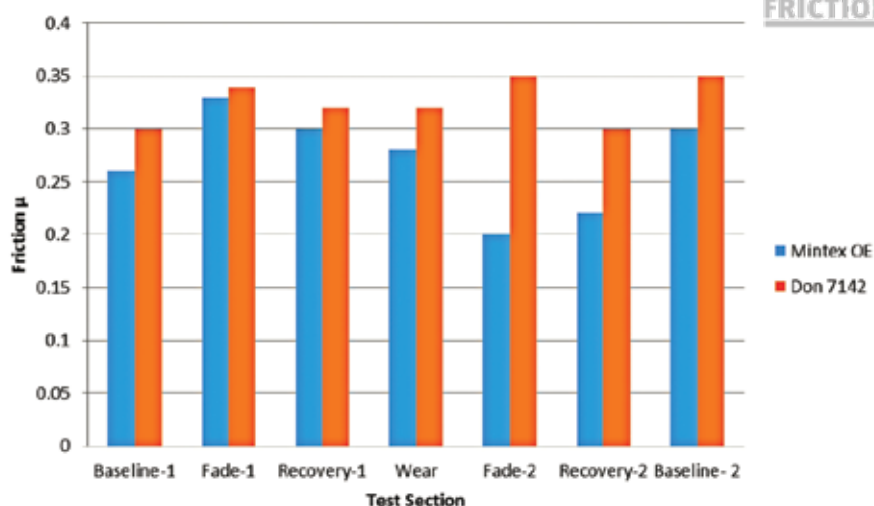
Dynamic Friction SAEJ661

↑ Graph from TMD Friction's report, comparing the original friction material used in Lancaster brake pads – Mintex A5 – shown in blue, with the modern friction material – Don 7142 – shown in orange. This illustrates that the new material is as good as or better than the original, with improved resistance to brake fade.

This report compared the original friction material with Don 7142 and showed that the recommended replacement material closely replicated the friction characteristics of the original and, in addition, had a greater resistance to brake fade. Using this new material the effectiveness of Lancaster wheel brakes will be at least as good as or even better than before, especially in an emergency braking event, and there should be no noticeable difference in brake operation or 'feel' to the pilots.

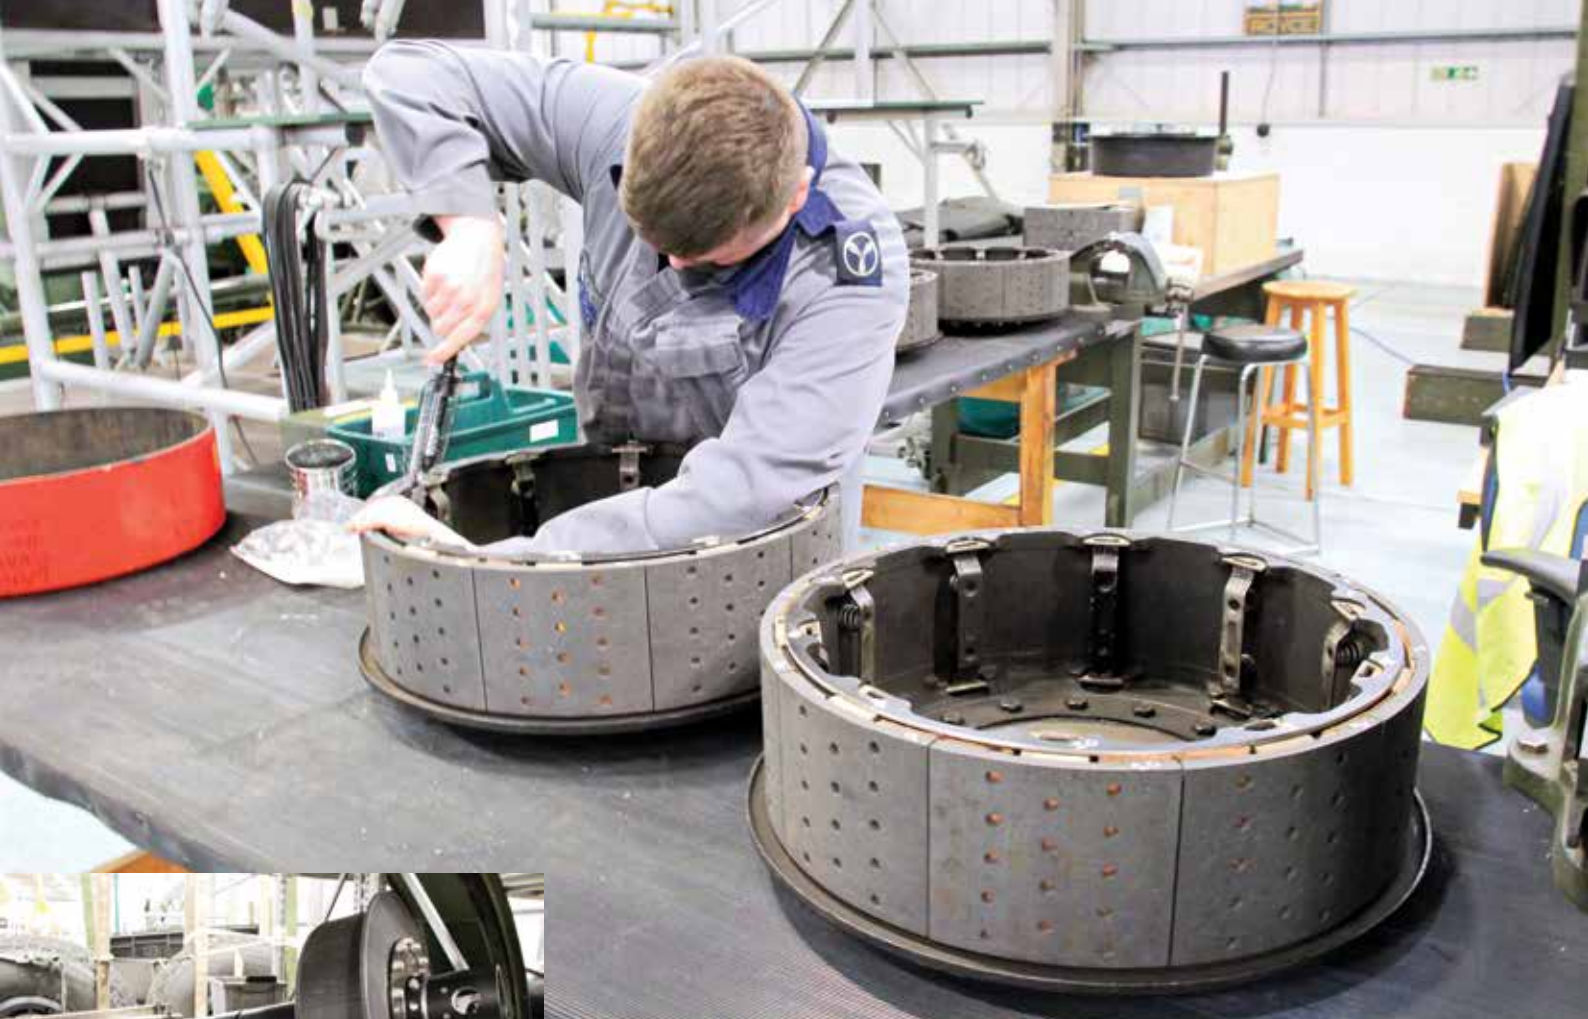
RAF BBMF technician SAC(T) Jack 'Buzz' Busby completing the fitment of the new brake shoes to the Lancaster brake hubs in the BBMF hangar in January 2020.
(All photos this page: Clive Rowley)

Following approval of the Safety Assessment and the supporting evidence by the TAA, a full set of new brake shoes, manufactured by Supermarine Engineering and using the new replacement friction material, Don 7142, was fitted to Lancaster PA474 over the 2019-20 winter maintenance period. This will allow the BBMF 'Lanc' to continue to operate into the future, with further sets of the new Lancaster brake shoes purchased by the BBMF Project Team to provide a source of spares.

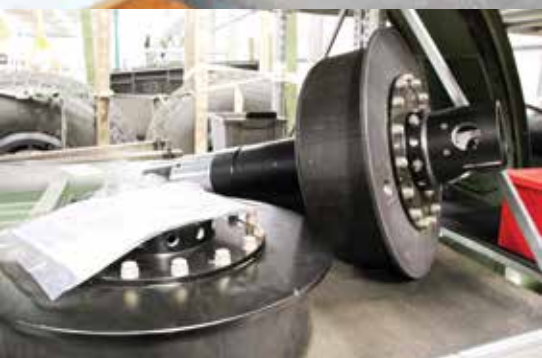
Lancaster brake hubs on a rack in the BBMF hangar, fitted with the pneumatic rubber brake bags but not with brake shoes. The hub on the right is attached to the wheel axle. The other brake hub would fit on the other end of the axle.
