# Maintenance – 4300 Mile Decoke Sept2004

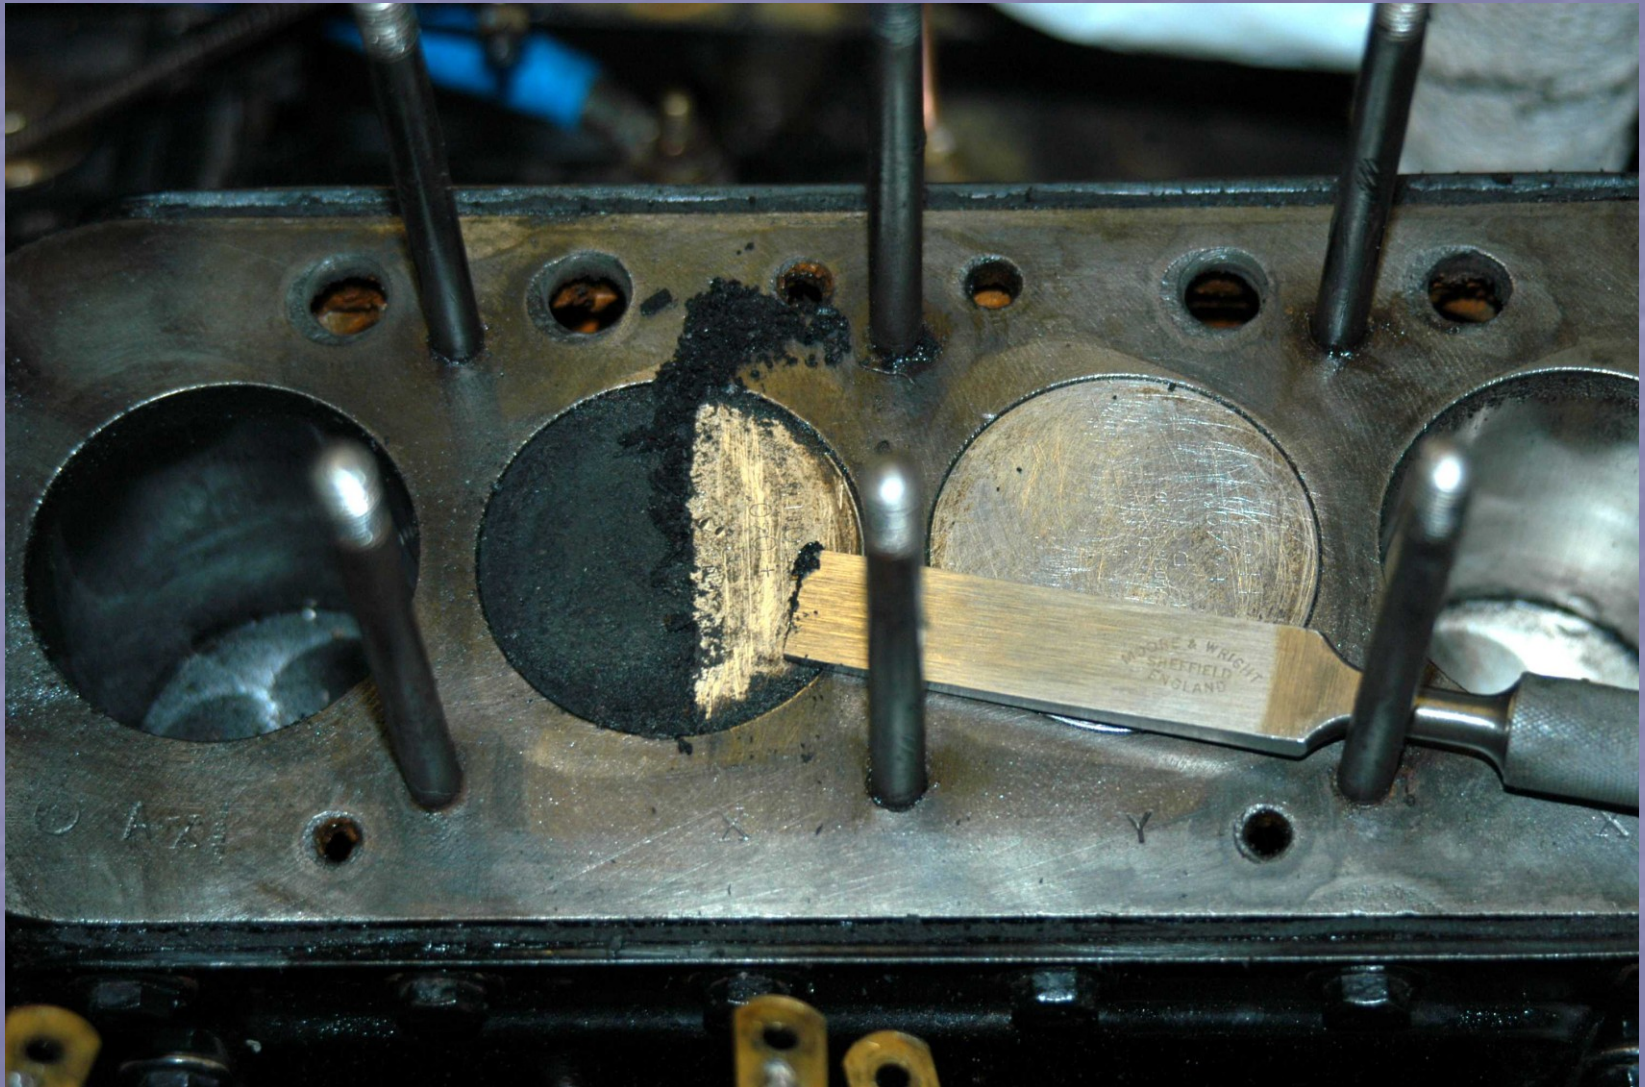
# Carbon Deposits Removed from Block & Pistons

Considering that only 4000 miles had been covered the amount of deposit was less than expected. However, the engine had a history of running rich.

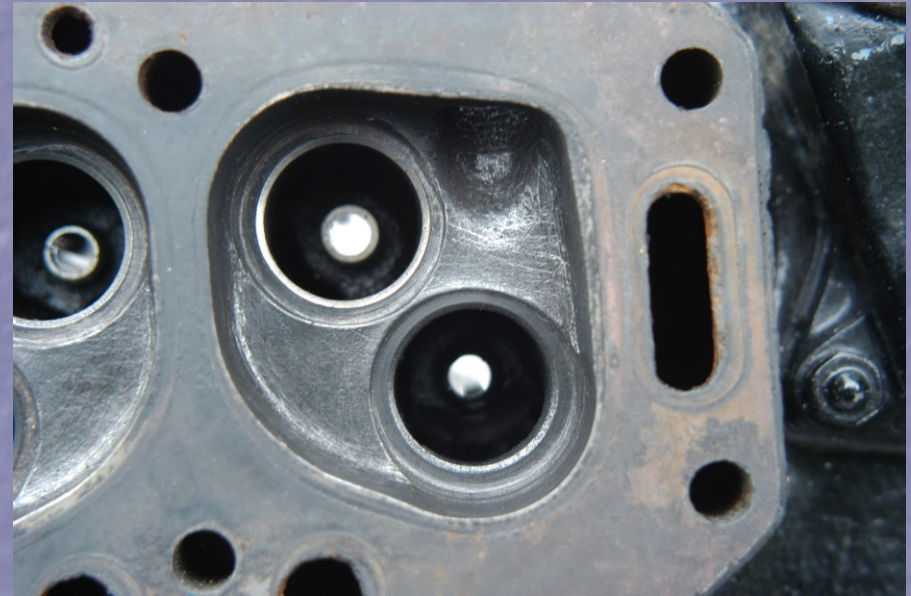
Valves Seats Cleaned Prior to Grinding In

- The Valves as removed before cleaning.
- No indications of poor sealing were seen

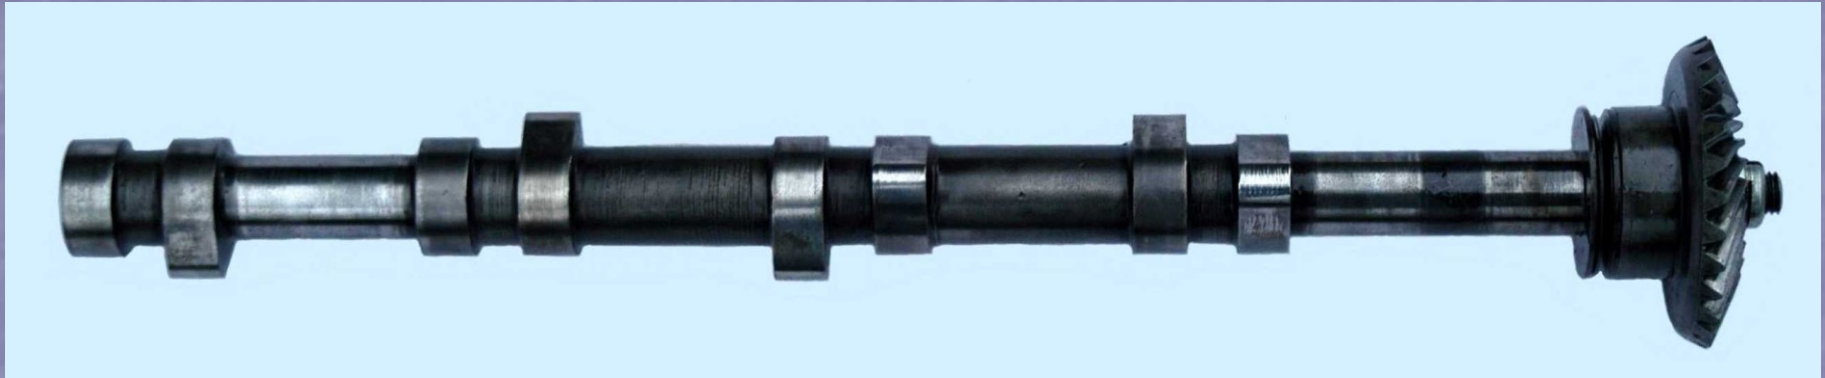
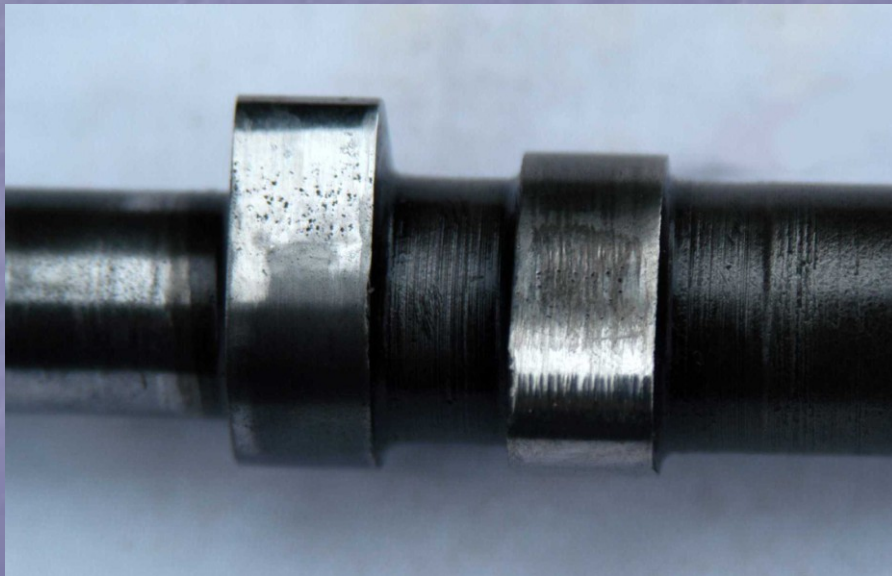
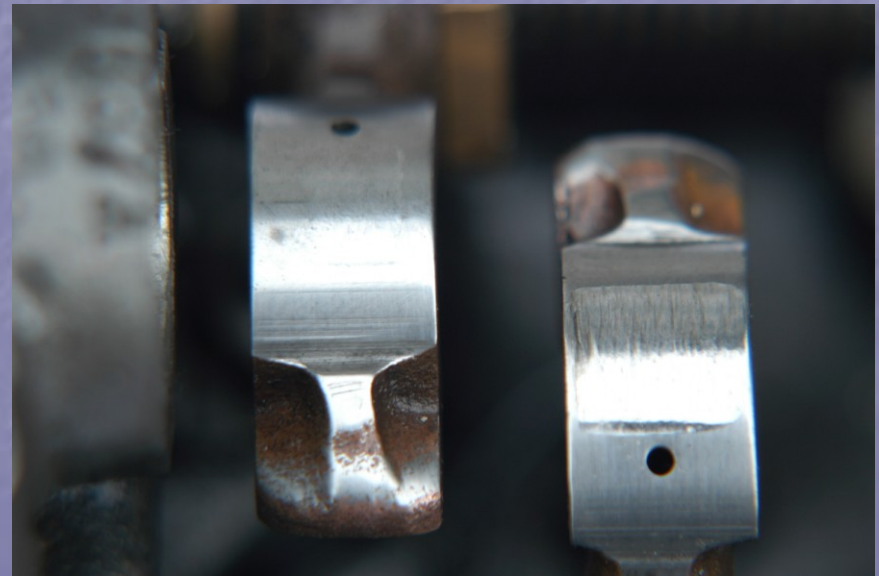
# Cam Shaft & Wear to Cam Followers

**The valve  
follower wear  
is considered  
acceptable**
